UNITED STATES DISTRICT COURT
FOR THE DISTRICT OF MASSACHUSETTS

**PLAINTIFFS' AMENDED OPPOSITION
TO DEFENDANTS' MOTION FOR
SUMMARY JUDGMENT**

B. Colgan's Alleged Maintenance Errors and Omissions	10
▪ <i>Events Leading to the Replacement of the Forward Elevator Trim Cable</i>	
▪ <i>Raytheon's Errors and Omissions - Instruction for the Trim Cable Replacement</i>

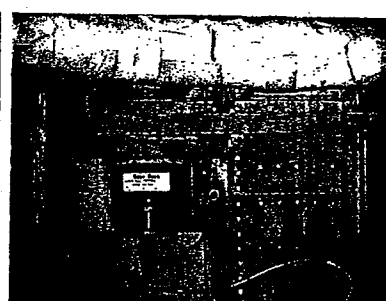
UC 103	Fair – Inspected fwd spar area, center wing fuselage area, aft spar area, fwd cabin belly area and aft cabin belly area. All areas inspected were dirty, damp and water was standing in some areas. No corrosion was noted.
S/N	Condition of Windows:
UE 71	Very good – Normal wear noted.
UE 221	Fair – All cabin windows had gravel damage and scratches.
UC 103	Fair – All cabin windows had gravel damage and scratches.
S/N	Damage/Repairs:
UE 71	Excellent – Repairs found were of good quality.
UE 221	Very good – Repairs found were of good quality.
UC 103	Very good – Repairs found were of good quality.
S/N	Condition of Wheel Wells and Gear:
UE 71	Good
UE 221	Fair – Required cleaning.
UC 103	Fair – Required cleaning.
S/N	Condition of Engines and Cowls:
UE 71	Very good – LH OB and RH IB plenum panels were delaminated.
UE 221	Good – LH OB and RH IB plenum panels were delaminated.
UC 103	Good – LH OB and RH IB plenum panels were delaminated.

Aft cabin belly fuselage

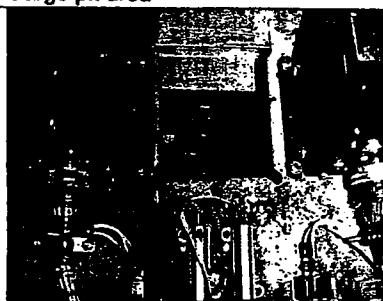
Aft of fwd spar - wet

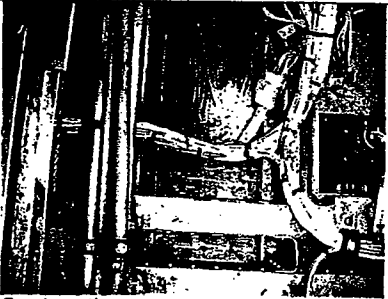
Center wing area - wet
